Comparison of sandblasted, ground and melt-etched zirconia crowns regarding adhesion strength to resin cement

Ketil Kvam, Aesha Irkayek, Eliza Vangaeva & Fadi El-Homsy

ABSTRACT

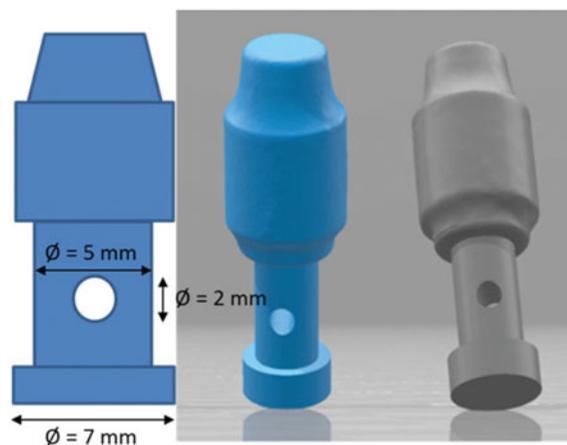
Figure 1. Dimensions and 3D view of the cobalt-chromium implant substitutes.

An implant substitute was designed by a 3D builder program (3D Builder, Microsoft, Dublin, Irland). One STL-file of this design was sent for production of 18 standardized implant substitutes in a cobalt-chromium alloy, Remanium[®] star CL (Table 1), with Selective Laser Melting (SLM) by 3D-TEC Sweden AB (Kristianstad, Sweden) according to the design modifications (Figure 1).

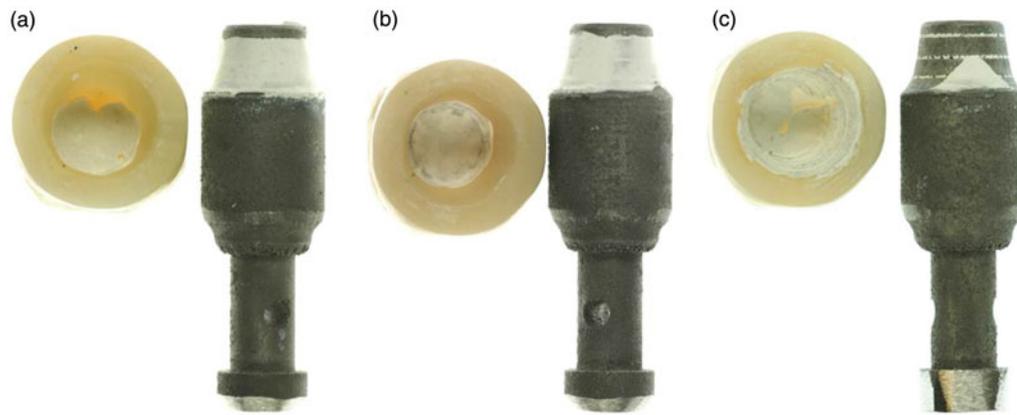
Figure 2. Crowns de-bonded from implant substitutes when the insides of the crowns are (a) sandblasted, (b) ground and (c) melt-etched with potassium hydrogen difluoride.

A model of tooth 36 was designed with CAD/CAM Zirkozahn Modellier-system for making 18 standardized Prettau Zirconia crowns (Table 1) for mounting to the implant abutments (Figure 2). The crown model was designed for a cement gap of 30 µm and with a 2 mm wide cervical margin which enable a steel grip to be loaded in tension. An abutment and the crown model were scanned with Zirkozahn scanner (Scanner S600 ARTI, Zirkozahn, Gais, Italy) and

The abutment substitutes were sandblasted with 110 µm alumina at an angle of 45° and a distance of 10 mm leaving circular traces as shown in Figure 2. This was done to ensure that the cement would adhere to the abutments and ensure that bonding between the cement and the zirconia surfaces on the inside of the crowns would be tested.

When inspected in stereo microscope prior to cementation, the inner surface exhibited different morphologies according to group (Figure 4). The sandblasted group had a rough surface, the ground surface was also rough with grinding grooves in different directions and the melt-etched surface looked shiny, but was matte at high magnifications. After tensile testing, the fracture morphology showed combinations of adhesive fracture to zirconia and cobalt-chromium surfaces, and cohesive fractures in the cement (Figure 2).

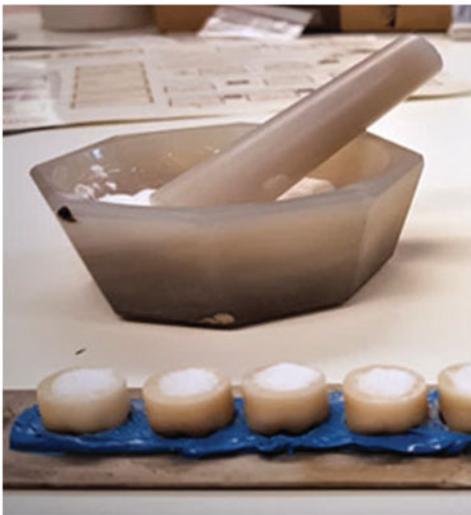
Figure 3. Potassium hydrogen difluoride crushed in a mortar and filled in crowns before melt-etching.

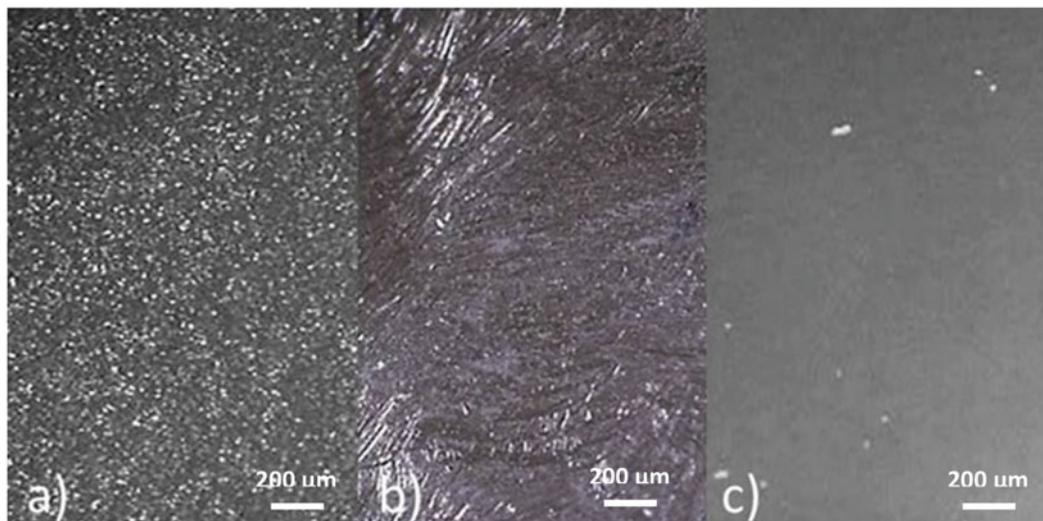
Figure 4. Inner surfaces of crowns, visualized in stereo microscope after (a) sandblasting, (b) grinding and (c) melt etching.

Wild Leitz, Heerbrugg, Switzerland) for evaluation of surface morphology after surface treatment both before and after the de-bonding test (Figure 4).

In a stereo microscope at low magnification (32X), only the sandblasted and ground surfaces appeared rough; the melt-etched surface looked smooth and shiny. At the higher magnification (64X), however, the melt-etched surface appeared to be matte indicating some roughness, apparently sufficient to provide a good retention. Static images of the texture of the inner curved surface taken at high magnification contained little information. However, Ruyter et al. [16], using scanning electron microscope on planar specimens, observed sub-micrometer scale undercuts due to melt-etching and 5 μ m scale undercuts due to sandblasting. The melt-etching may also have left a surface with a surface energy that differed from the mechanical treatments and a better affinity to the resin cement. As discussed in a recently published study [18], the melt etch technique with KHF_2 can have resulted in fluoridated surface which has attached hydroxyl groups after water cleaning giving a positive effect on the adhesion.

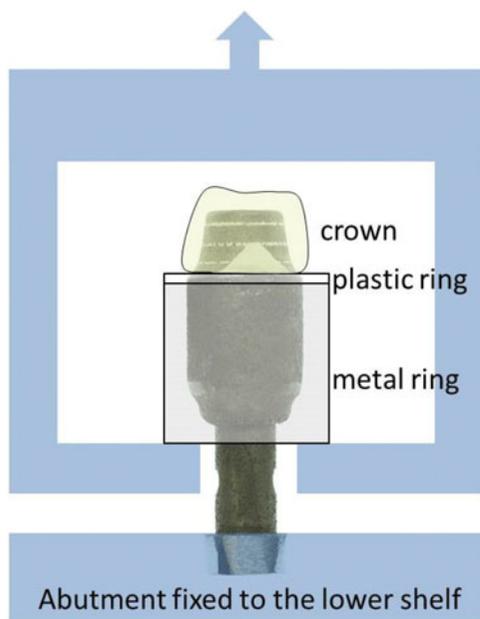
Figure 5. The tensile system schematically drawn with one of the group 3C abutment substitutes.

The abutment substitutes with the cemented crowns were tested in a universal test machine, Lloyds LRX (Lloyds Instruments Ltd, Fareham, UK). A metal cylinder and a plastic ring with an inner diameter less than the crown margin were placed around the abutment substitutes before these were mounted in the machine and clamped (Figure 5). The

metal cylinder was then fixed to the upper drive to be pulled up during loading so that the plastic ring distributed the load around the crown margin. The crosshead speed was 1 mm/min. The tensile force was measured until the cemented crowns fully de-bonded from the abutments.
